U.K. Loft Boarding LTD.

A Critical and Technical Loft-Fixture Product Testing Report

2023 Undergraduate Summer Internship

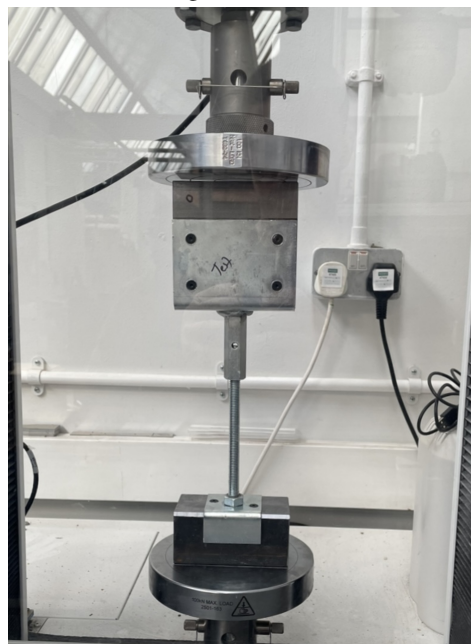
Figure 2.4
Design Point Schematic and Test Piece

(a) Design Point Schematic

(b) Design Point Preliminary Test

Whilst there will be a normal reaction force, F_R , it is not labelled on the schematics due to the way in which the Instron 3369 Universal Testing Machine works in that it only registers the compression force that is being applied by the upper plate, rather than sensing a reaction

force from the lower plate. This is so that any force measured, is purely that of which the machine has added. Due to $W_B \lll F_C$ it can be considered negligible and that it would not affect the obtained results in any noteworthy fashion. The entire system can be simplified to a be a vertical column that is fixed at both ends. The company mentioned that they were manufacturing the loft legs from mild steel which was plated in stainless steel, so when it comes to theoretical calculations the value for Young's modulus will be 200GPa [9]. Additionally, as the slender section of the test samples is a M10x1.5 threaded bar, an average diameter of 9.25mm will be taken instead of 10mm or 8.5mm. Also, the length, L , of the slender section is to be taken as 150mm in the design point case.

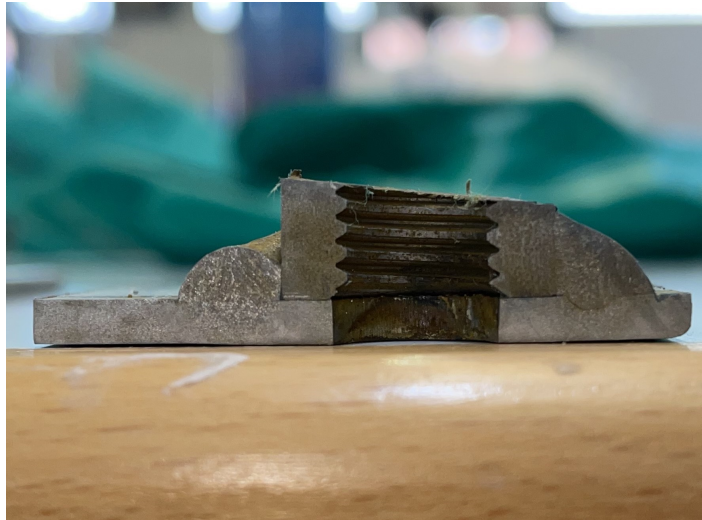
Figure 3.1
Two Etched Weld Samples

It was found that when inspecting the upper and lower welded modules of the 5 test samples, all of them had the same issue. This was that whilst the weld was penetrating the substrate L bracket, it was not penetrating the M10 hex threaded bar on the upper module, as well as weld material not being applied all the way into the corners underneath the M10 hex bar and the M10 nut on the upper and lower modules respectively.

In addition to this, the size of the weld was fairly standard and uniform, however it did vary slightly which could be a point of interest for improvement in the manufacturing process. These small issues can be put down to human error, which can potentially be avoided if machine welding is utilised instead. This would, of course, come with financial implications. On one of the lower modules, a small crack became visible once the material had been etched, see fig.3.1a, in between the weld material and the substrate. This could simply be an imperfection in the material or it could have occurred post-weld.

(a) Etched Upper Module Weld

(b) Etched Lower Module Weld

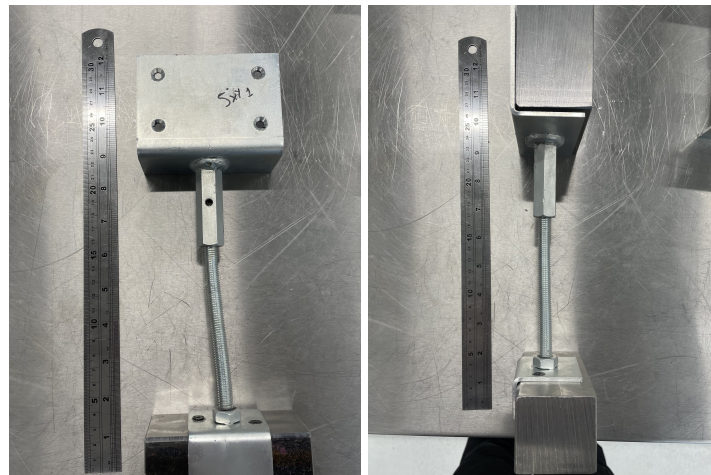
Figure 3.4
5°XY Test

The mode of failure for the off-design point tests was 1st mode buckling, however when comparing to the different modes of buckling shown in fig.2.6 the shape of the buckle in both the XY and ZY planes, matches the 6th type of buckling where the value of K equals 1 with both ends being fixed - causing rotation to be fixed - but with translation being free.

(a) 5°XY Front

(b) 5°XY Side

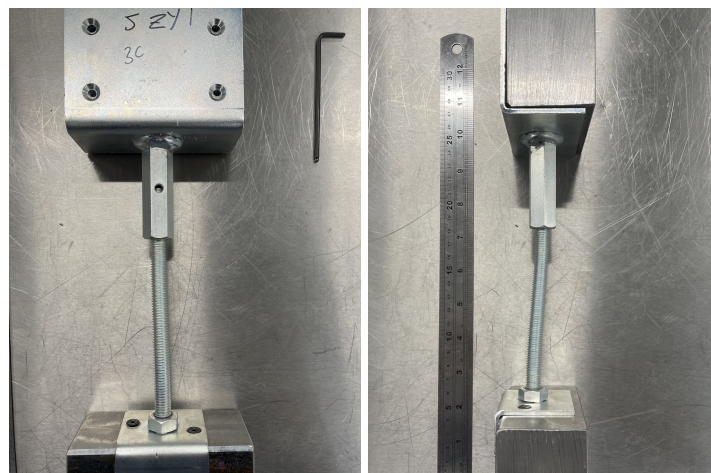
Figure 3.5
5°ZY Test

(a) 5°ZY Front

(b) 5°ZY side

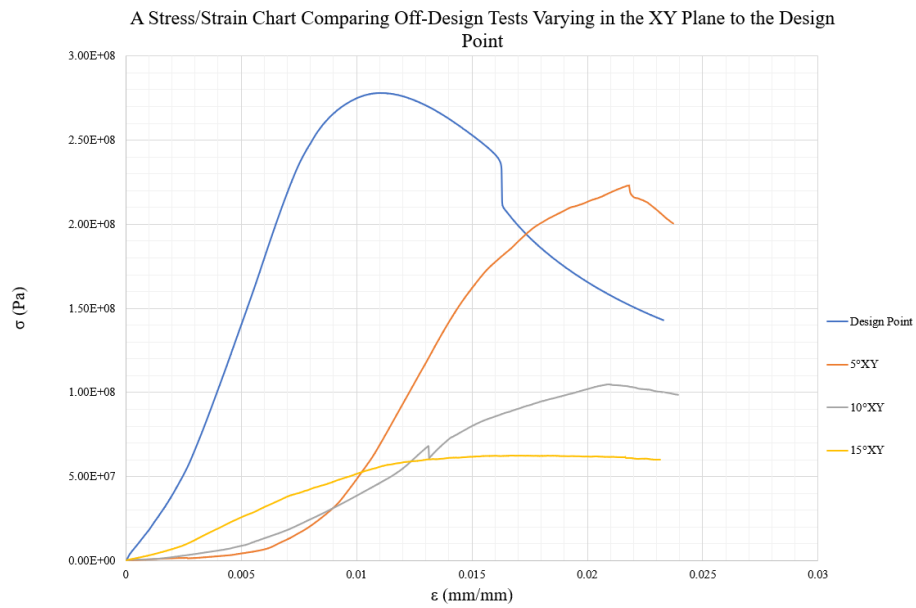
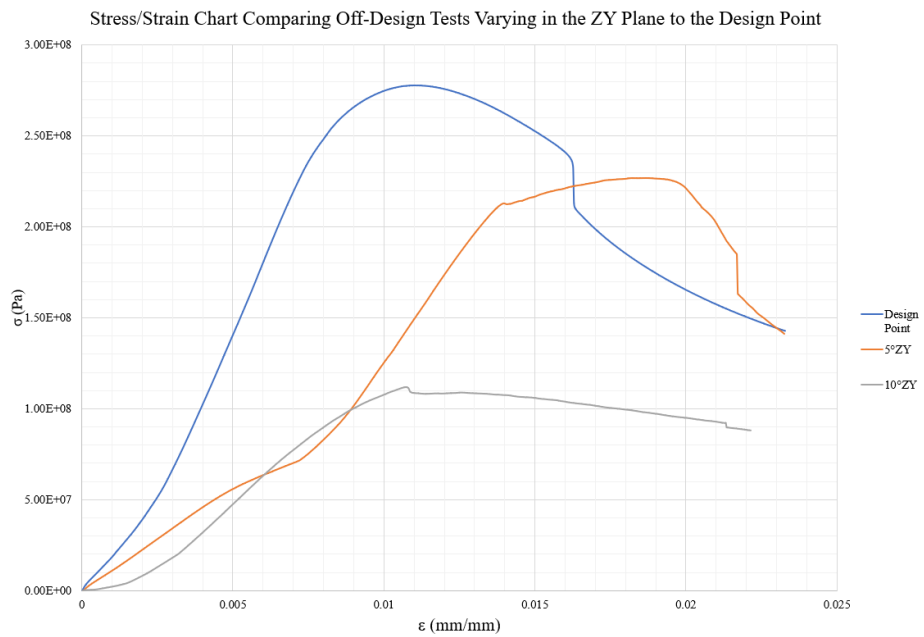
Figure 3.6
Eccentric Loading Results

It was found that for the off-design XY planar tests, the critical loads for the 5°, 10° and 15° tests were 14.976kN, 7.032kN and 4.187kN respectively. This shows that there is a 20%, 62% and 78% decrease in peak strength respectively in comparison to the design point.

(a) σ/ϵ Off-Design in XY Plane

(b) σ/ϵ Off-Design in ZY Plane

For the off-design ZY planar tests, the critical loads for the 5° and 10° tests were 15.258kN and 7.521kN respectively. This shows that there is an 18% and 60% decrease in peak strength respectively in comparison to the design point.
